## TEST REPORT

Report Number ORT251018112001-R01					
Sample Name:	Smartphone		Applicant:	Shenzhen Huafurui Technology Co., Ltd.	
Model:	KINGKONG ACE 5		Address:	Unit 601-03, 6/F, Block A, Building 1, Ganfeng Technology Building, No. 993 Jiaxian Road, Xiangjiaotang Community, Bantian Street, Longgang District, Shenzhen, P.R. China	
Spec:	Black		Vendor or Supplier:	Shenzhen Huafurui Technology Co., Ltd.	
Brand:	CUBOT		Address:	Unit 601-03, 6/F, Block A, Building 1, Ganfeng Technology Building, No. 993 Jiaxian Road, Xiangjiaotang Community, Bantian Street, Longgang District, Shenzhen, P.R. China	
Sample Quantity:	5 Pcs		Manufacturer:	Shenzhen Huafurui Technology Co., Ltd.	
Specimen Source:	Submitted by applicant		Address:	Unit 601-03, 6/F, Block A, Building 1, Ganfeng Technology Building, No. 993 Jiaxian Road, Xiangjiaotang Community, Bantian Street, Longgang District, Shenzhen, P.R. China	
Received Date:	Oct. 19, 2025	Detection Date:	Oct. 20, 2025~ Oct. 27, 2025	Report Date:	Oct. 27, 2025

Test Requirement:	For further details, please refer to the following page(s).				
Test Item:	1.IPX9K Test; 2.IP6KX Test; 3.IP6X Test; 4.IPX8 Test; 5.Vibration Test; 6.Combined Temperature and Sho

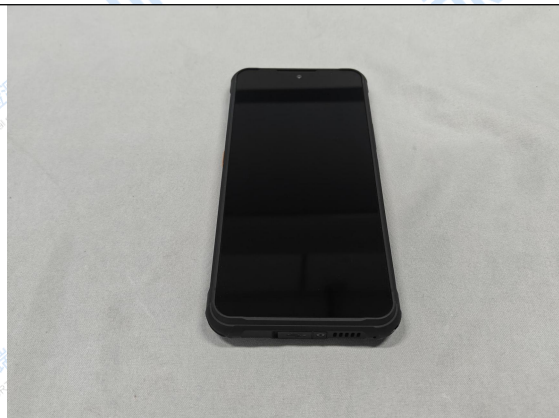
Fig.5 Appearance inspection after test

Sample No.	Inspection after test	Conclusion
ORT251018112001-SS1/5	There's no damage to the appearance of sample and the function is normal.	Pass

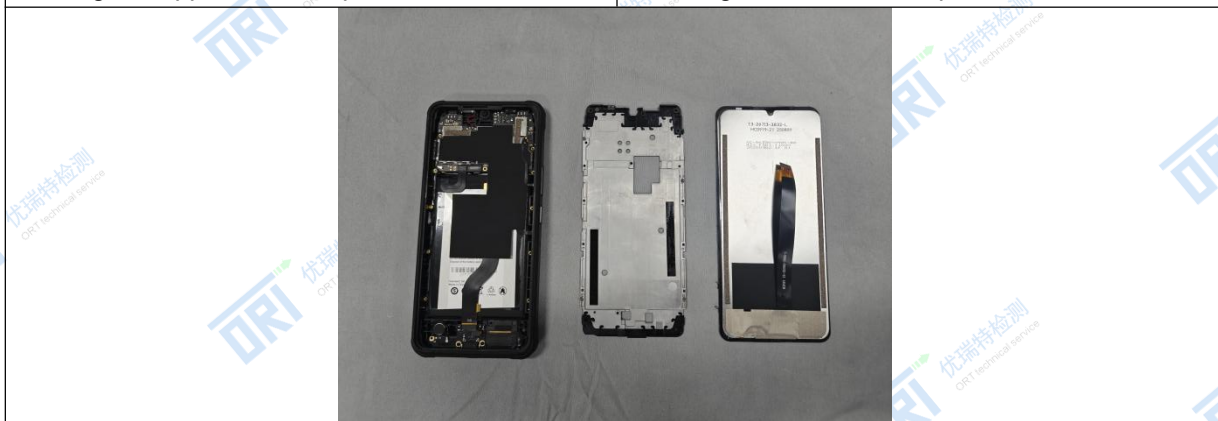
Fig.39 Inspection after disassembly

Sample No.	Inspection after test	Conclusion
ORT251018112001-SS3/5	The appearance of sample is normal and the function is normal. The sample was not punctured by the test probe and there was sufficient clearance between the sample and the hazardous parts. After the disassembly inspection, there is no dust inside.	Pass

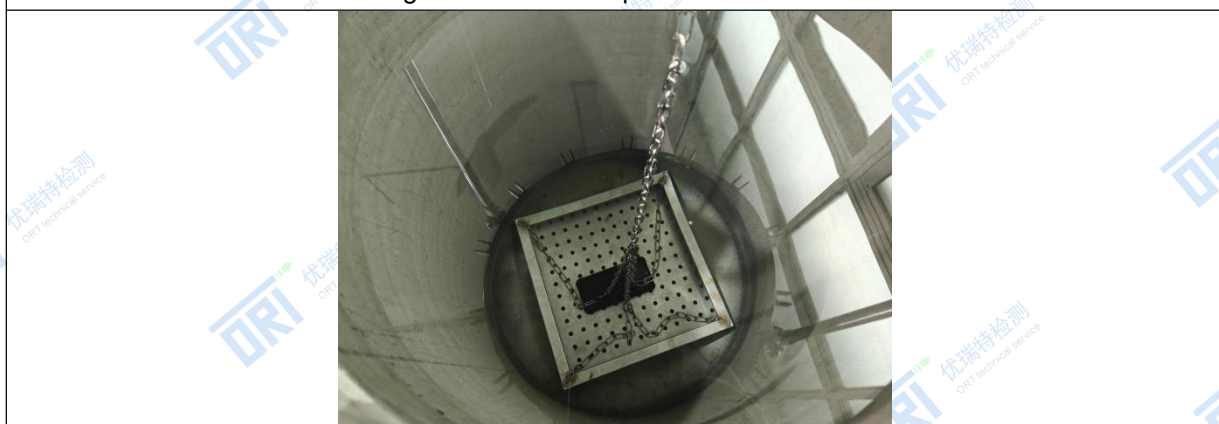
Fig.43 Test setup

- 1) Put the sample into the test device;
- 2) Depth: 1.5 m; Test duration: 30 min;
- 3) The temperature difference between the water and the sample is no more than 5 K.

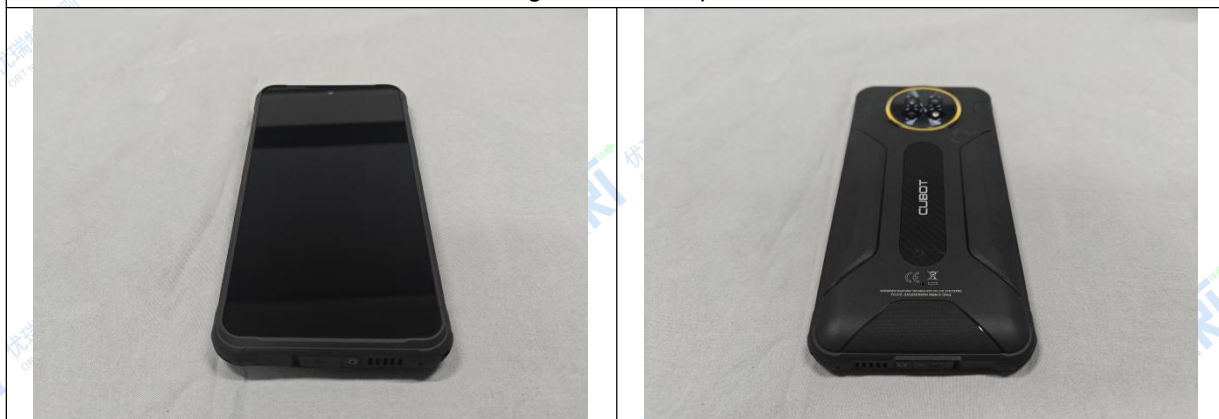
Fig.44 Appearance inspection after test

Sample No.	Inspection after test	Conclusion
ORT251018112001-SS4/5	The function is normal; And after disassembly, there is no water inside the sample.	Pass

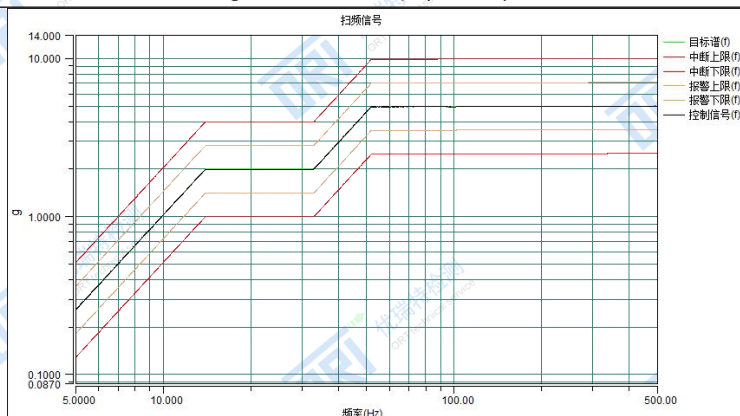
Fig.54 Test Spectrum (X axis)

Frequency (Hz)	Acceleration (g)	Displacement (mm)	Test axis	Test time
5~14	/	5.08	X, Y, Z axis	2 h/axis
14~33	2	/		
33~52	/	0.91		
52~500	5	/

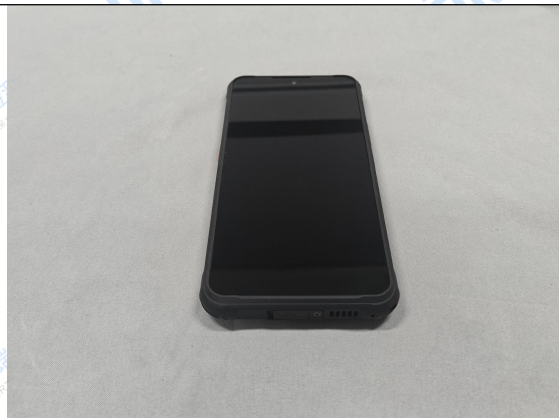
Fig.57 Appearance inspection after test

Sample No.	Inspection after test	Conclusion
ORT251018112001-SS1/5	The appearance of sample is normal and the function is normal.	Pass

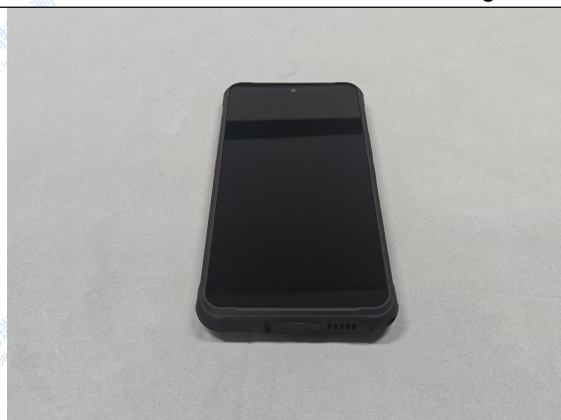
Fig.70 Appearance inspection after test

Sample No.	Inspection after test	Conclusion
ORT251018112001-SS5/5	The appearance of sample is normal and the function is normal.	Pass
